## Infrared Thermographic Inspection

Provided for  
Your Facility Name Here

Report Date: 9/18/2013

**Current Inspection No: 1234**  
**Report Date: 9/18/2013**  
**Inspected By : Joe Thermo**

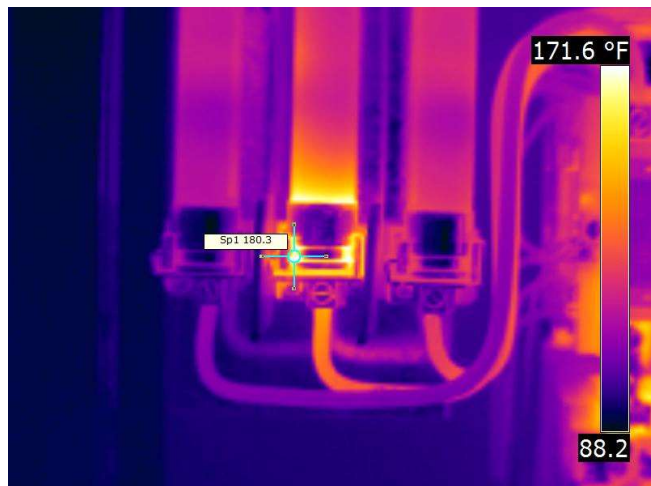
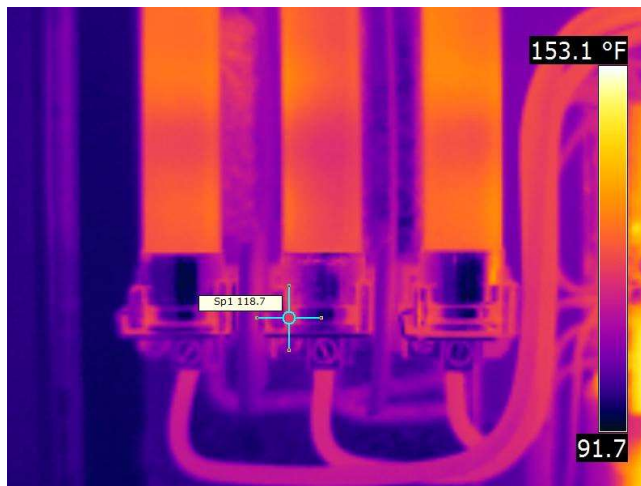
**Location:** 1st Floor  
Boiler Room  
MCC

Target Point	Reference Point	Temperature Difference	Severity: 1-Critical
.B-Phase: 180 F	.A-Phase: 111 F	69 F

Target is MCC Sec 1 - Disconnect Labeled - A/C #3 - 45A Fuse Bank - B-Phase Load Side Fuse Clip - Connection Defect on Disconnect. \*\*REPAIRED ON SITE NEW TEMP 118 SEE IR PHOTO\*\*

No corrective action required. FIXED ON SITE.

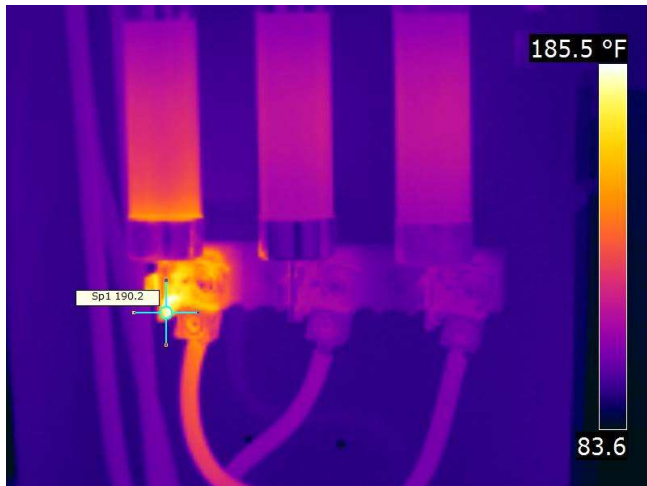
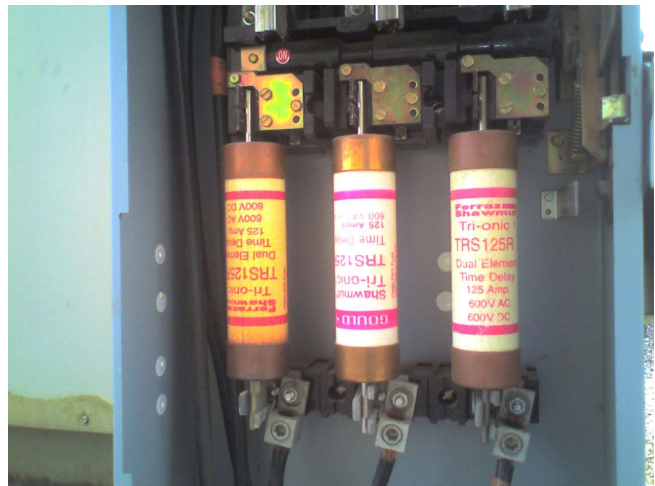
**Location:** Roofs  
**Materials Management**  
**AC-2 Cond. Unit**

Target Point	Reference Point	Temperature Difference	Severity: 1-Critical
.A-Phase: 190 F	.C-Phase: 109 F	81 F

Target is 125A Fused Disconnect - A-Phase Load Side Fuse Clip - Connection Defect on Disconnect-Fused

Shut off power to target. Remove fuse and fuse clip assembly. Clean and repair or replace as needed. Upon completion rescan target with heat gun.

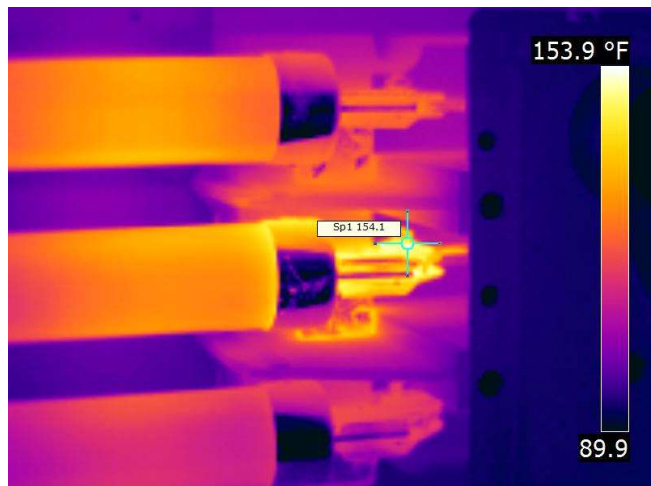
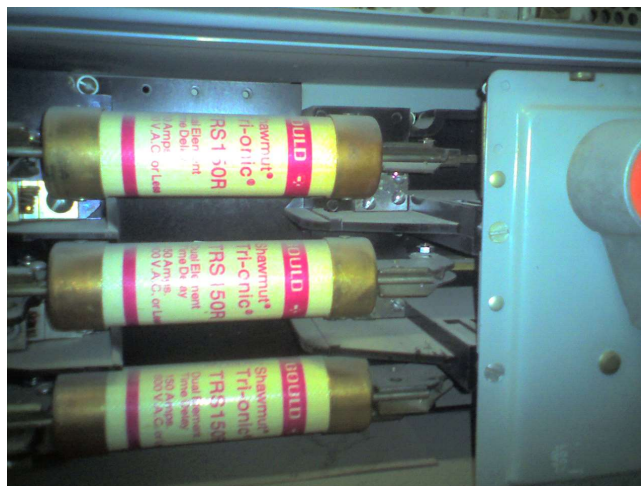
**Location:** 1st Floor  
Main Distribution Room 1st Floor  
SDPA (4 sections)

Target Point	Reference Point	Temperature Difference	Severity: 3-Important
.B-Phase: 154 F	.C-Phase: 122 F	32 F

Target is Switchboard - SDPA Sec 3 - Disconnect Labeled - FEEDER PANEL 2A,3A,4A,5A - B-Phase Line Side - Connection Defect on Disconnect-Fused.

Shut off power to target. Remove fuse and fuse clip assembly. Clean and repair or replace as needed. Upon completion rescan target with heat gun.

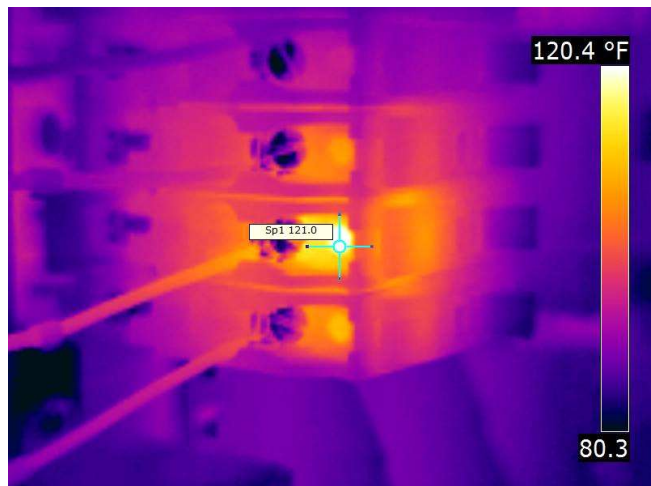
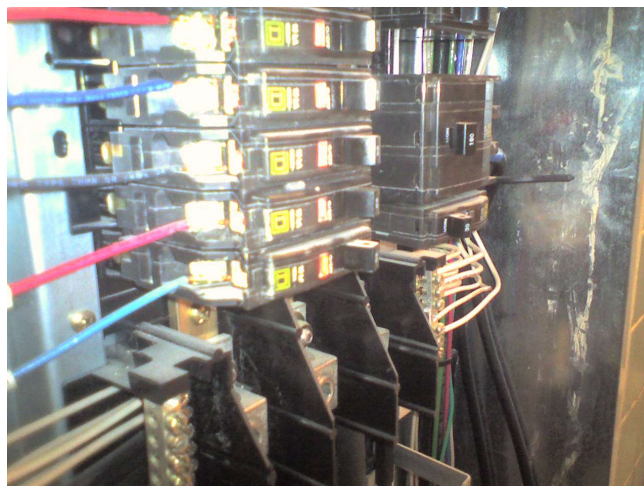
**Location: 1st Floor  
Café (Serving Area & Serving Line)  
K-3**

Target Point	Reference Point	Temperature Difference	Severity: 3-Important
Breaker #39: 121 F	Breaker #41: 103 F	18 F

Target is Branch Panel - K-3 - Breaker #39 a 20A 1P - Connection Defect / Breaker Wear on Breaker

Shut off power to breaker. Remove wire and inspect breaker assembly. If breaker appears to be faulty, replace as necessary. Otherwise, clean and re-install wire.

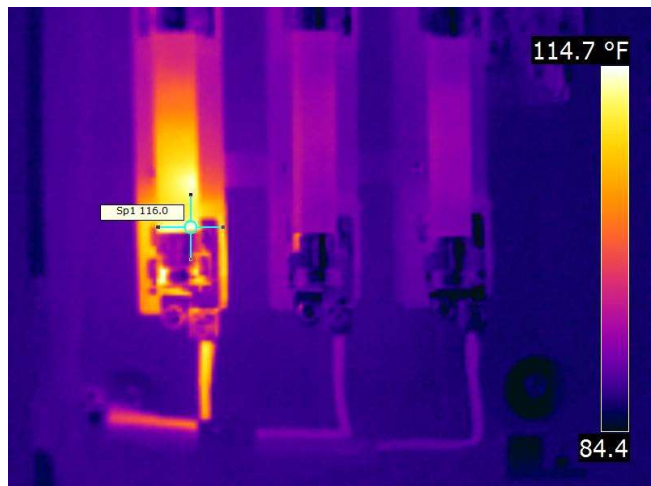
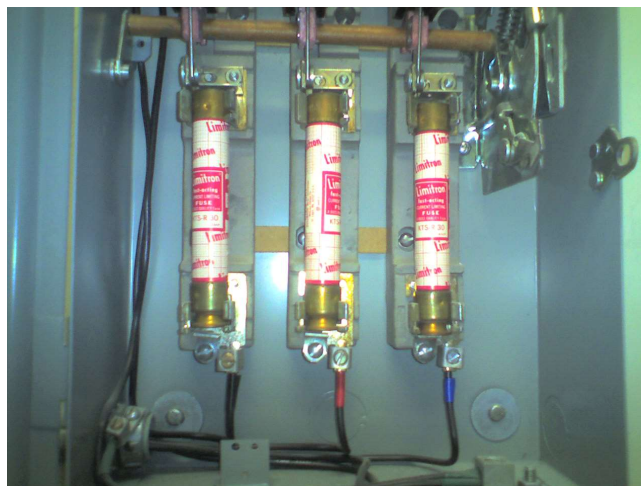
**Location:** 3rd Floor  
**Triumph Electrical Room**  
**T-3EC**

Target Point	Reference Point	Temperature Difference	Severity: 3-Important
.A-Phase: 116 F	.C-Phase: 89 F	27 F

Shut off power to target. Remove fuse and fuse clip assembly. Clean and repair or replace as needed. Upon completion rescan target with heat gun.

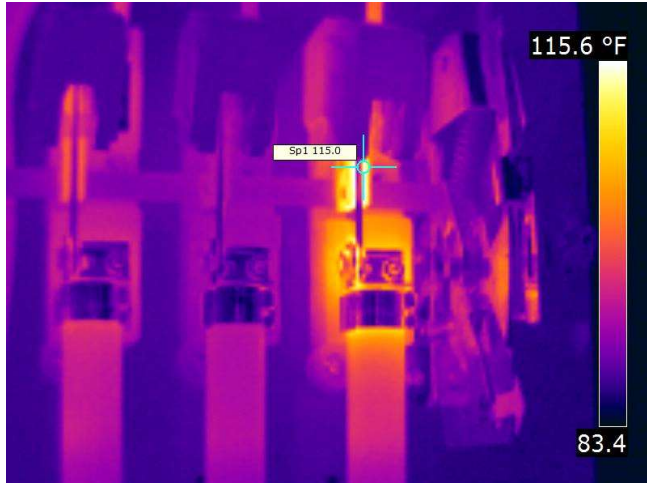
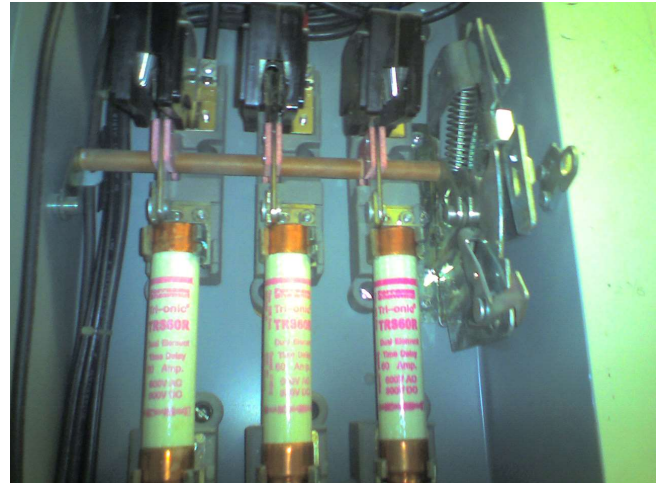
**Location:** 3rd Floor  
**Triumph Electrical Room**  
**AC1**

Target Point	Reference Point	Temperature Difference	Severity: 3-Important
.C-Phase: 115 F	.B-Phase: 95 F	20 F

Target is 60A Fused Disconnect - C-Phase Line Side - Connection Defect on Disconnect-Fused

Shut off power to target. Remove fuse and fuse clip assembly. Clean and repair or replace as needed. Upon completion rescan target with heat gun.

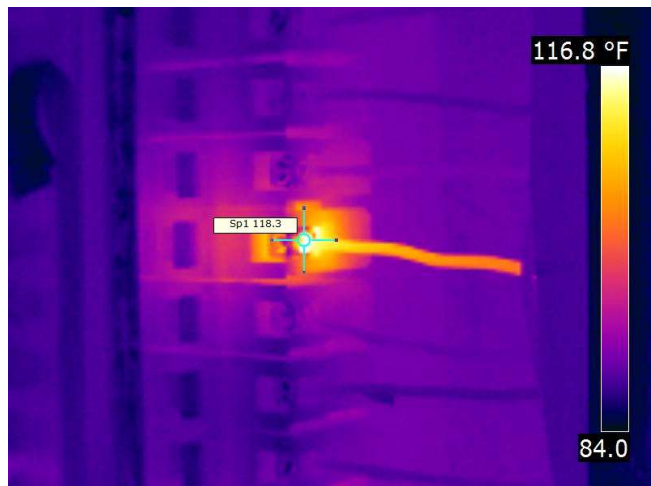
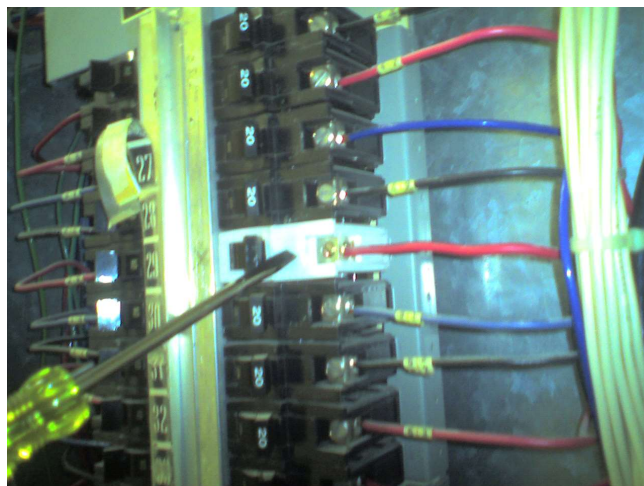
**Location: 3rd Floor  
Triumph Electrical Room  
3A (right)**

Target Point	Reference Point	Temperature Difference	Severity: 3-Important
Breaker #50: 118 F	Breaker 51: 93 F	25 F

The load exceeds 80 % of the device rating. This is a National Electric Code violation

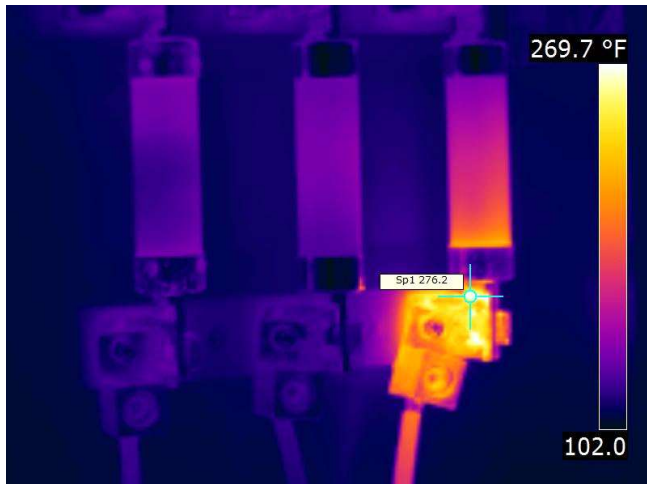
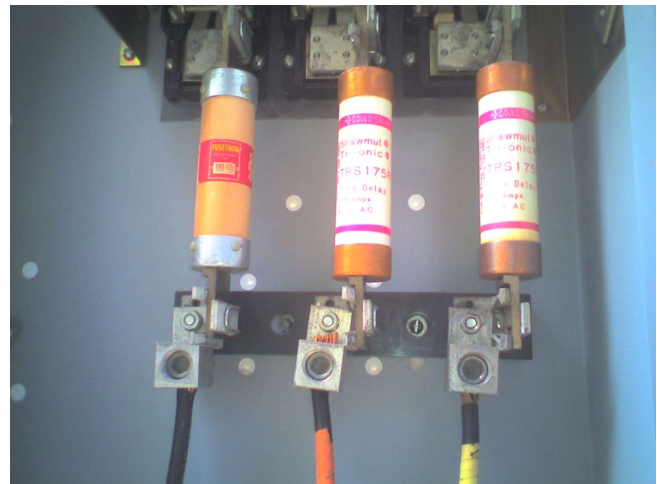
**Location:** Roofs  
**ER**  
**A/C 1 COND UNIT**

Target Point	Reference Point	Temperature Difference	Severity: 1-Critical
.C-Phase: 276 F	.B-Phase: 102 F	174 F

Target is 175A Fused Disconnect - A/C 1 Cond Unit - C-Phase Load Side - Connection Defect on Disconnect.

Shut off power to target. Remove fuse and fuse clip assembly. Clean and repair or replace as needed. Upon completion rescan target with heat gun.

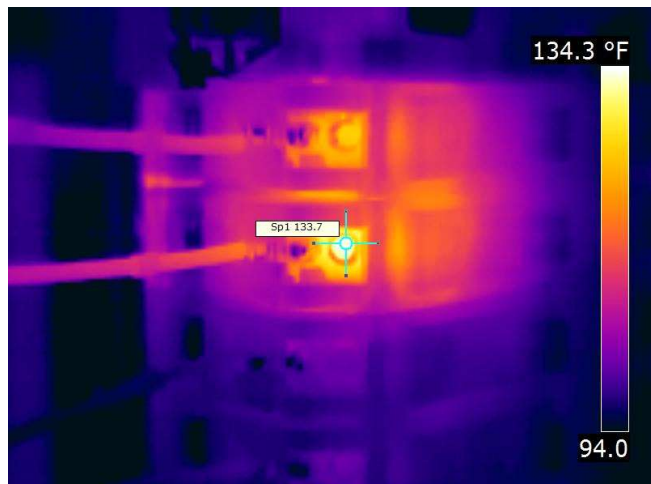
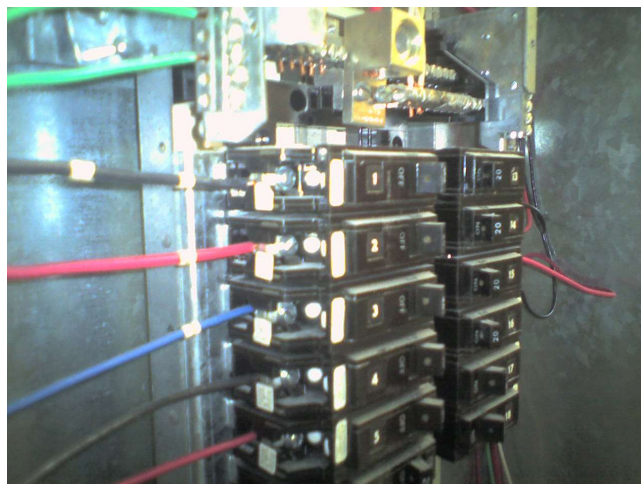
**Location: 4th Floor  
East Electrical Room  
4EA**

Target Point	Reference Point	Temperature Difference	Severity: 3-Important
Breaker #2: 133 F	Breaker #3: 102 F	31 F

Target is Branch Panel - 4EA - Breaker #2 a 20A 1P - Connection Defect / Breaker Wear on Breaker. (Feeds: 4th Fl Corridor LTG)

Shut off power to breaker. Remove wire and inspect breaker assembly. If breaker appears to be faulty, replace as necessary. Otherwise, clean and re-install wire.

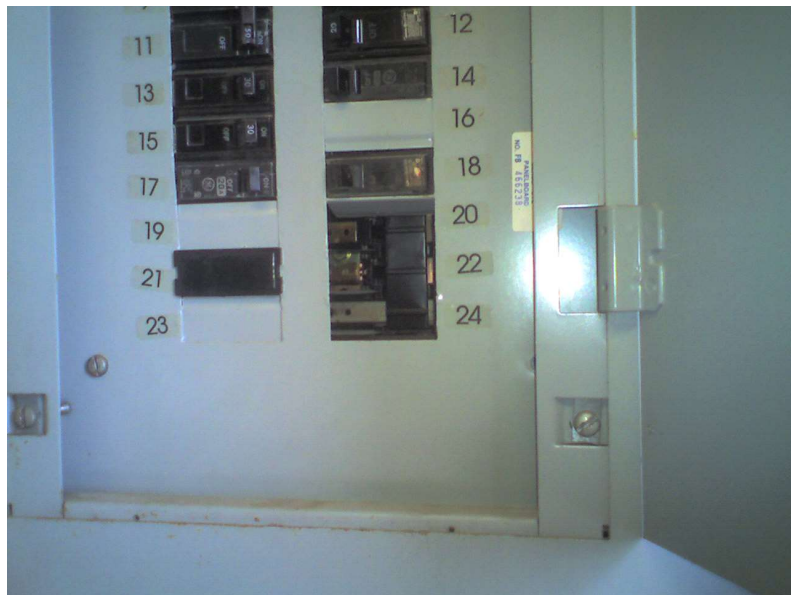
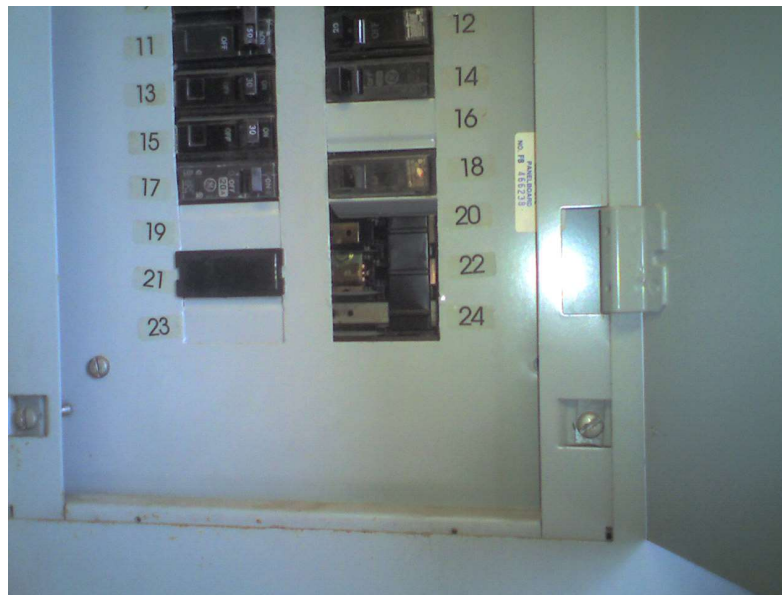
File: DC_4140.jpg	Date: 9/17/2013	Time: 11:13 AM
File: DC_4140.jpg	Date: 9/17/2013	Time: 11:13 AM

**Hazard Issue:** NEC Code Violation - Breaker Slot Covers Missing

**Observations:** Target is Branch Panel - EA - Circuit Breaker's - #20 - 24 - Exposed energized parts NEC Code Violation - Breaker Slot Covers Missing

**What is the Cause:** Missing Breaker Slot Covers

**Recommendations:** Replace Slot Covers At Once.

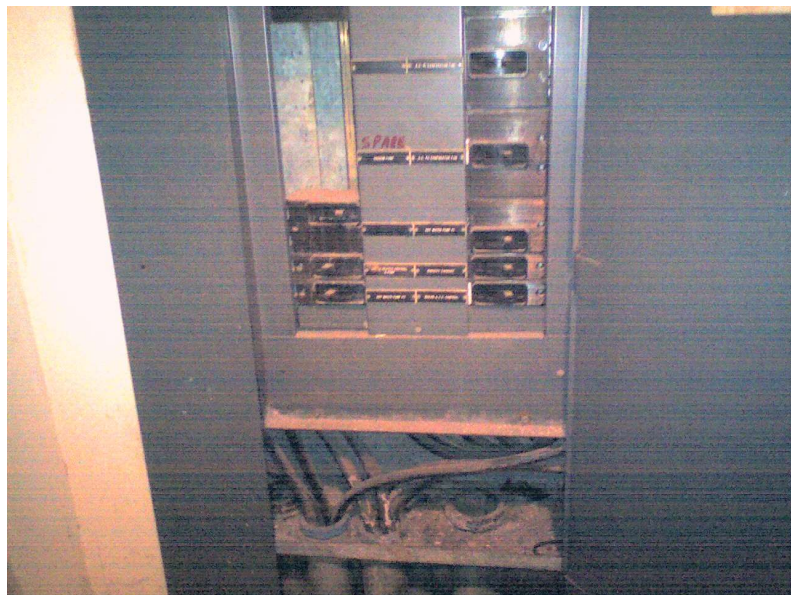
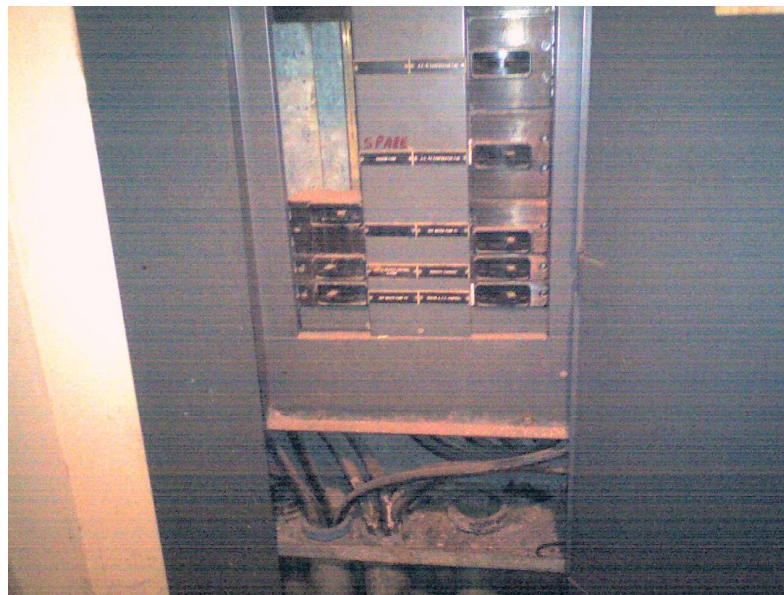
File: DC_4141.jpg	Date: 9/17/2013	Time: 11:18 AM
File: DC_4141.jpg	Date: 9/17/2013	Time: 11:18 AM

**Hazard Classification:** Missing front cover

**Observations:** Target is Distribution Panel - NDPW - NEC Code Violation - Front Cover Missing & Unused Breaker Slot Openings - Exposed energized parts Death, personal injury or equipment lose due to object entry into unsealed holes in equipment enclosure

**What is the Cause:** Opening not covered as per the National Electric Code.

**Recommendations:** Repair as per the National Electric Code
